**REPORT ON
PERIODIC STRUCTURAL STABILITY ASSESSMENT
POND 003
NEW MADRID POWER PLANT
NEW MADRID, MISSOURI**

by Haley & Aldrich, Inc.
Cleveland, Ohio

for Associated Electric Cooperative, Inc.
New Madrid, Missouri

File No. 129342-046
October 2021

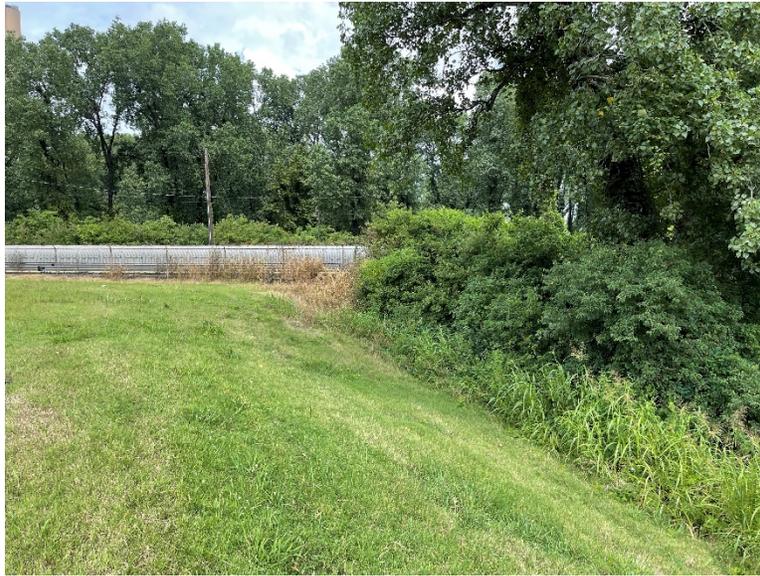
Photograph No. 1
Pond 003
Downstream slope of embankment at northeast corner of unit

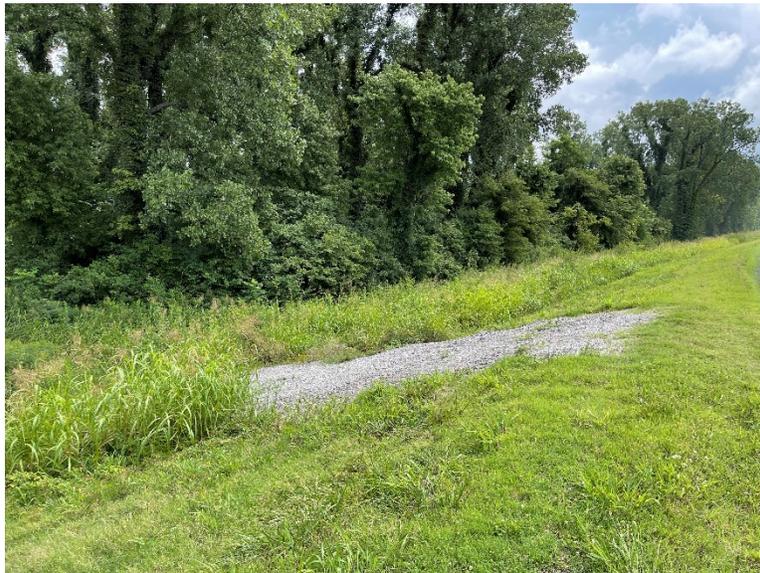
Photograph No. 2
Pond 003
Graveled access point to monitoring wells on downstream slope of eastern embankment

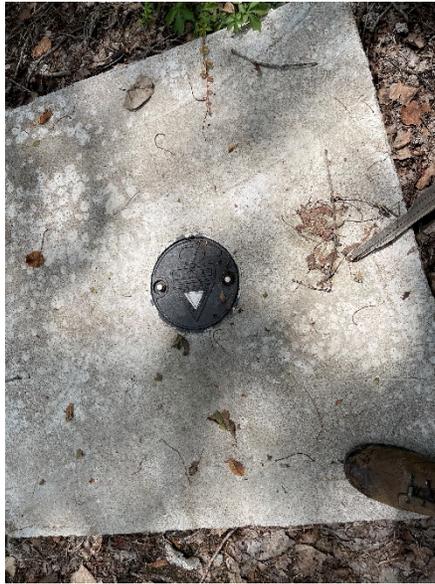
Photograph No. 3
Pond 003

Monitoring well located between eastern embankment of unit and Mississippi River

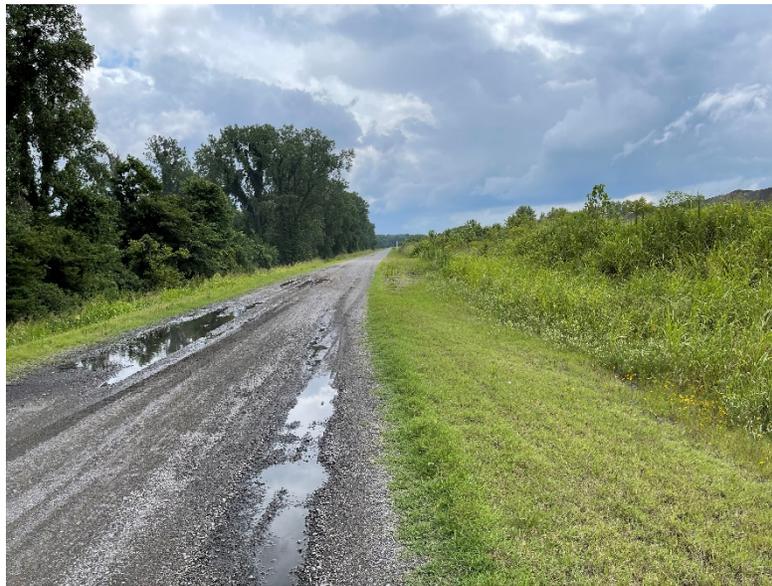
Photograph No. 4
Pond 003

Rutting on eastern embankment crest

- Cut/mow the embankments and routinely mow the embankment slopes (upstream and downstream) and downstream areas to maintain vegetation at a height of 6 in. or less.
- Monitor the mature trees downstream of Pond 003 for signs of decay and impact to the dike during the weekly and monthly inspections.
- Conduct a video inspection of outlet pipe from the drop inlet structures when flow is reduced to expose the downstream end of the pipe.
- Repair the rutting on the embankment crest. Additional gravel should be added as necessary.

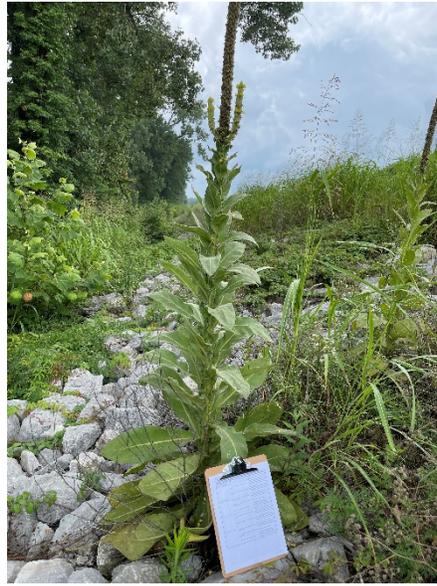
Photograph No. 5
Pond 003

The bottom half of the downstream slope of the eastern embankment was covered in riprap. Grassy vegetation was observed within the riprap, some of which exceeded a height of 48-in.

At the time of our impoundment inspection, portions of the north and east downstream slopes had vegetation taller than 6 inches in height. The taller vegetation (as high as 48-in.) was primarily observed within the riprap of the bottom half of the eastern embankment. On the upstream slopes, some vegetation was higher as well, some as high as 36 inches.

Vegetation in riprap on downstream slope of eastern embankment

- Cut/mow the embankments and routinely mow the embankment slopes (upstream and downstream) and downstream areas to maintain vegetation at a height of 6 in. or less.
- Remove vegetation from riprap on upstream and downstream slopes via herbicide or other corrective method.
- Monitor the mature trees downstream of Pond 003 for signs of decay and impact to the dike during the weekly and monthly inspections.
- Repair the rutting on the embankment crest. Additional gravel should be added as necessary.
- Conduct a video inspection of outlet pipe from the drop inlet structures when flow is reduced to expose the downstream end of the pipe.

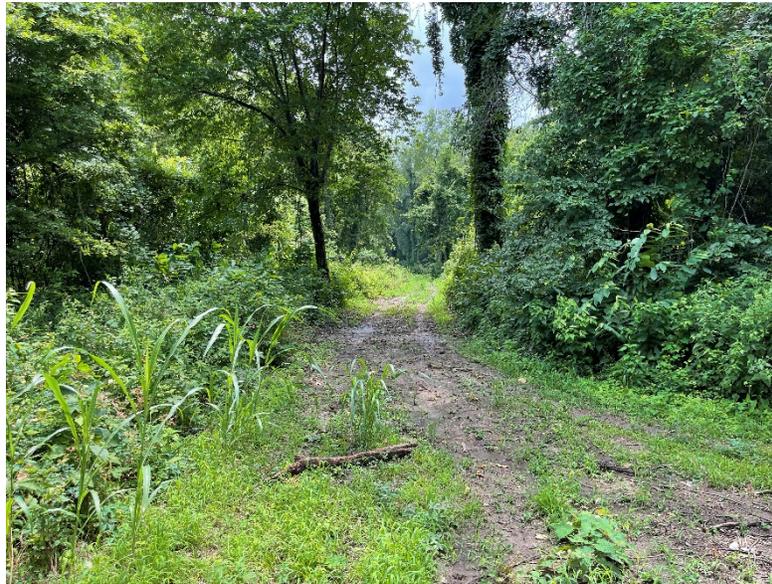
Photograph No. 6
Pond 003

Access to monitoring wells between eastern embankment of unit and Mississippi River

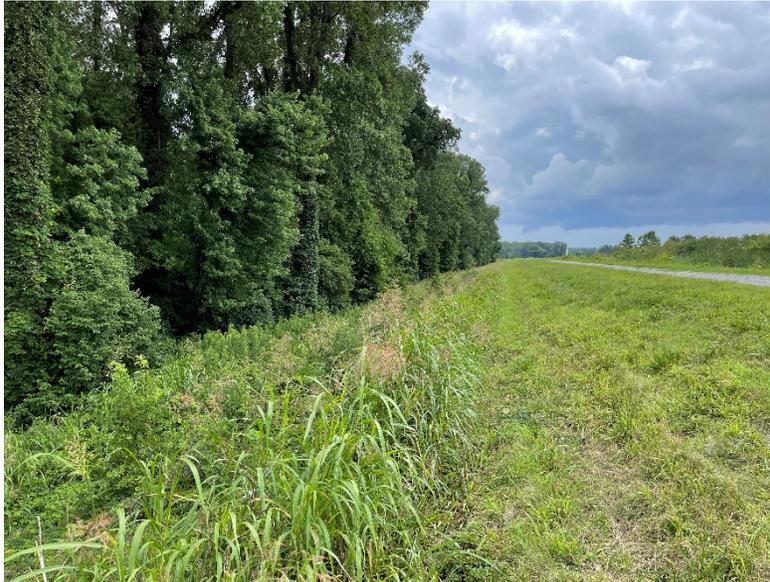
Photograph No. 7
Pond 003
Vegetation on downstream slope of eastern embankment

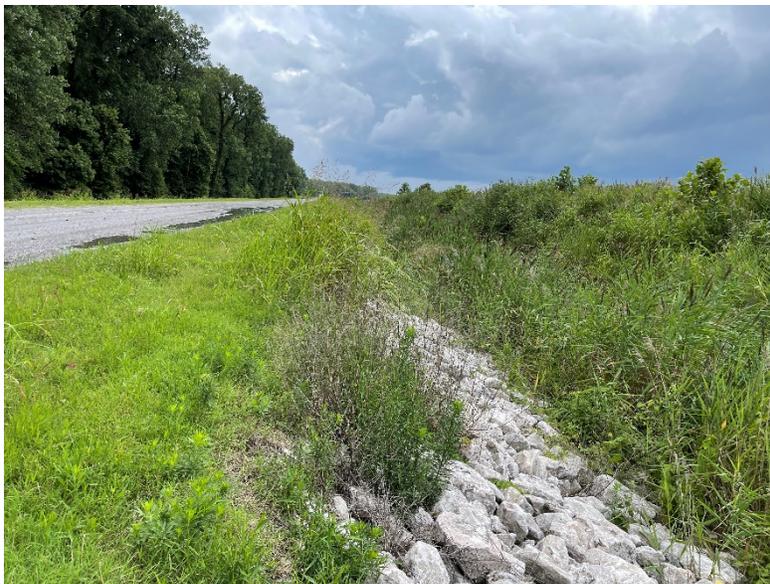
Photograph No. 8
Pond 003
Vegetation and riprap on upstream slope of eastern embankment
Interior drainage channel at right

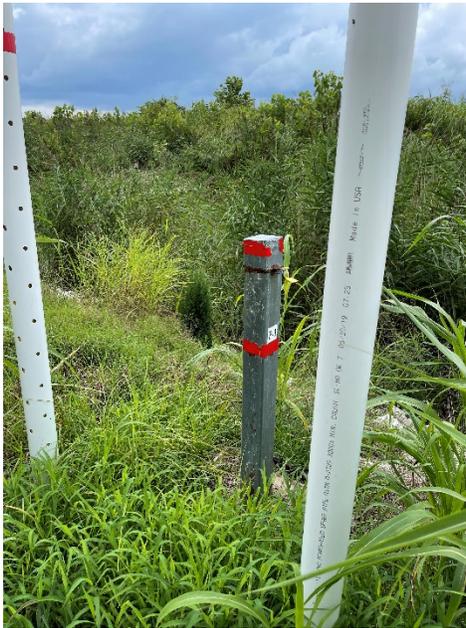
Photograph No. 9
Pond 003
Monitoring well on upstream slope of eastern embankment

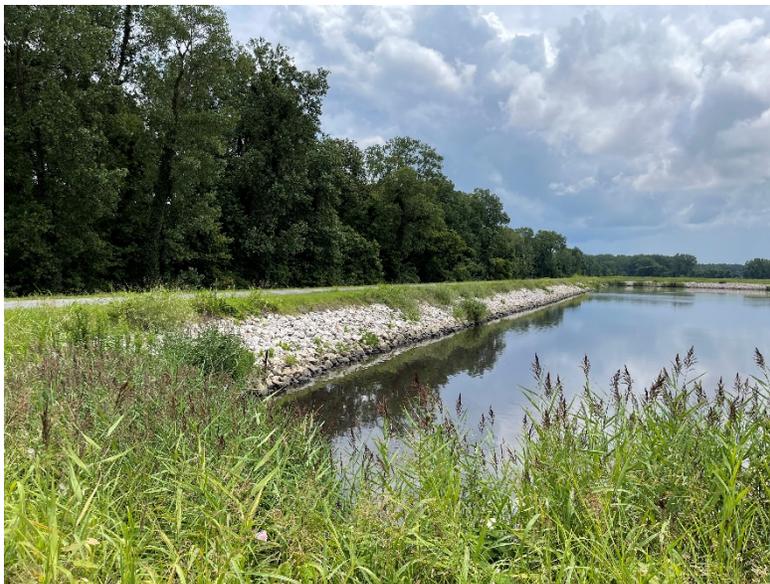
Photograph No. 10
Pond 003
Riprap on upstream slope of southern portion of eastern embankment (ponding area)

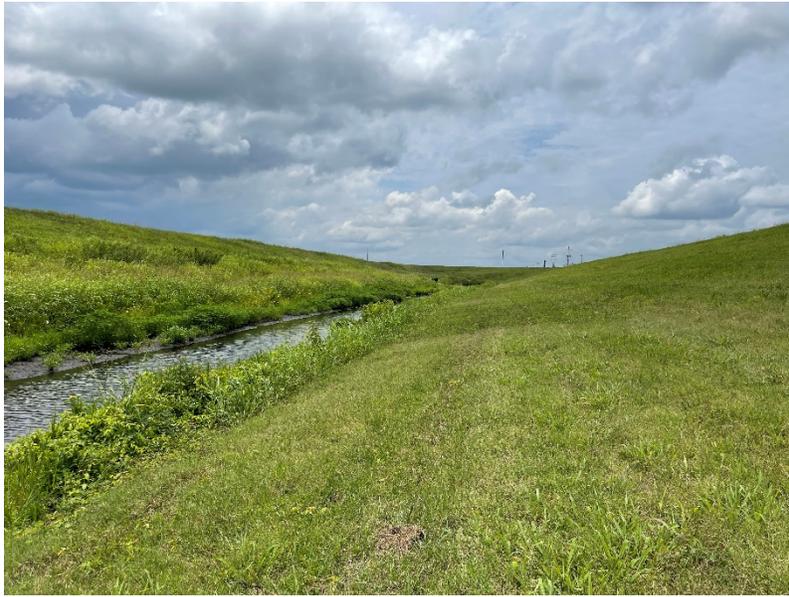
Photograph No. 11
Pond 003
Downstream slope of southern embankment
Discharge channel at left

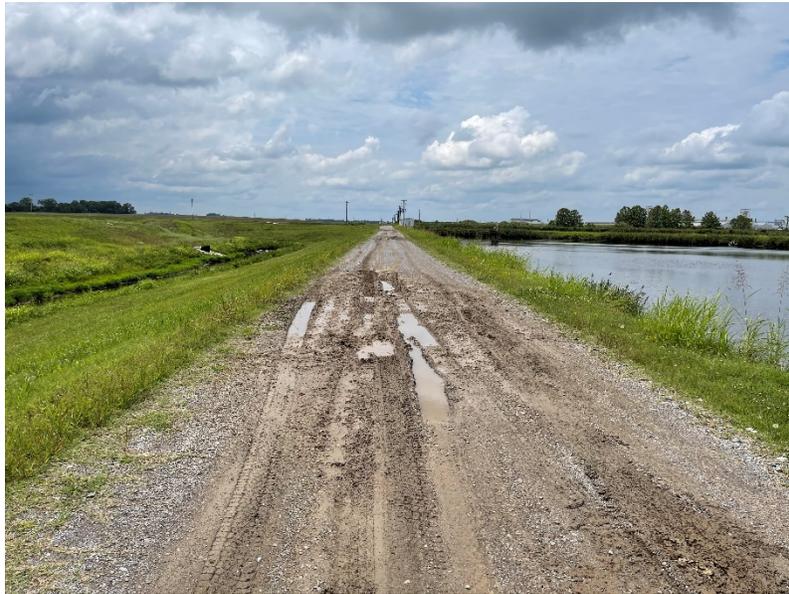
Photograph No. 12
Pond 003
Rutting in crest of eastern portion of southern embankment

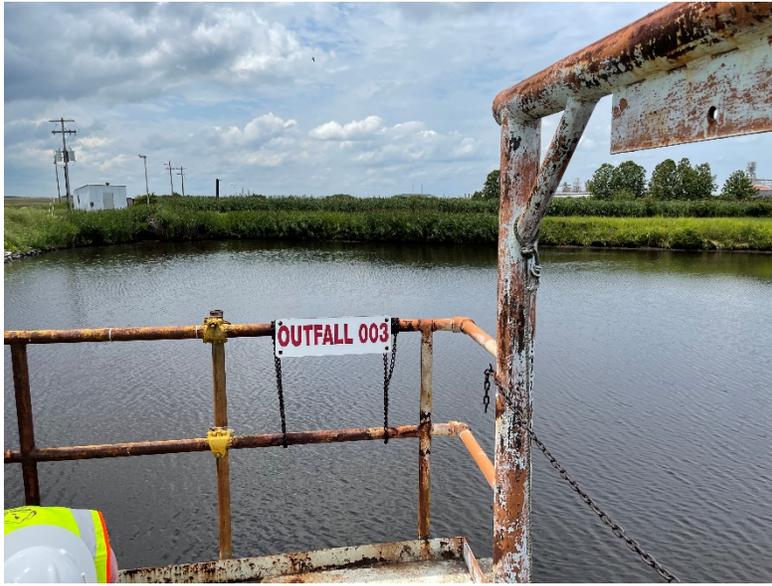
Pond 003 discharges through a concrete decant structure located at the southeastern end of the impoundment. Being a concrete structure, the structure is non-erodible and appears to be in good condition. There is no emergency spillway.

Photograph No. 13
Pond 003
Outlet structure and Outfall 003 signage

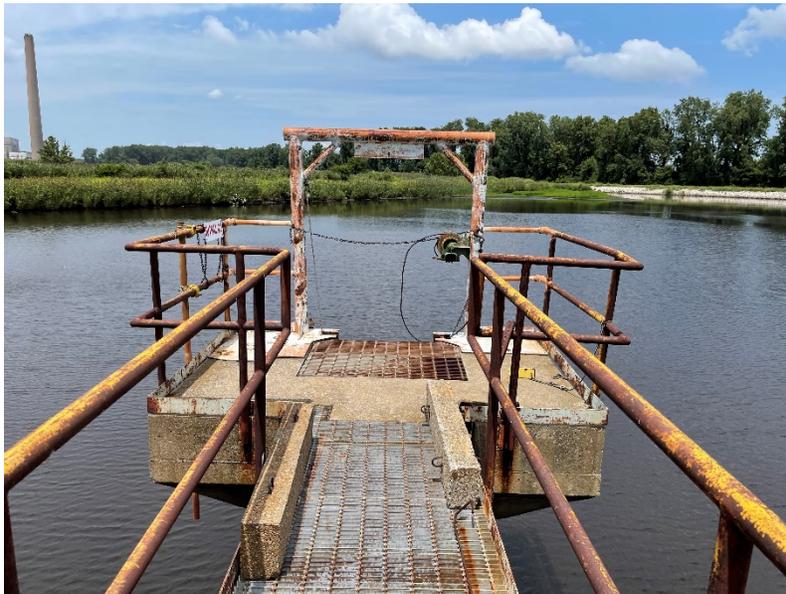
Photograph No. 14
Pond 003
Outlet structure

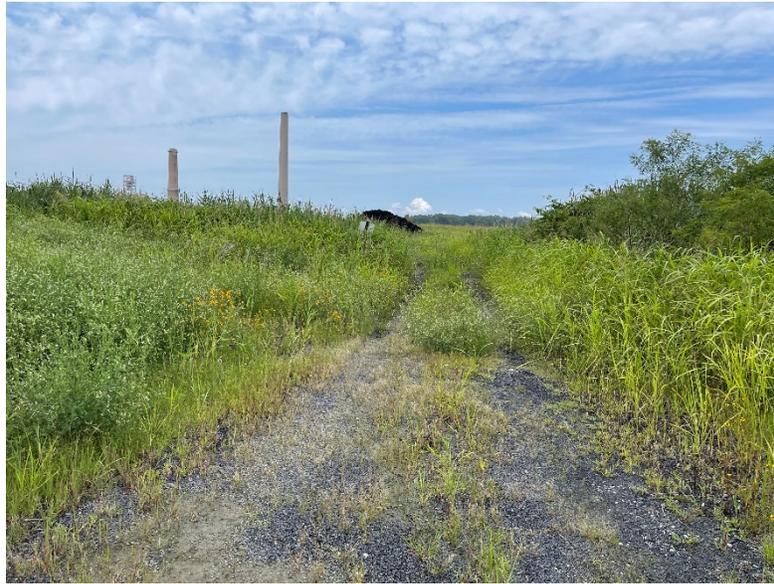
Photograph No. 15
Pond 003
Interior access point from southern embankment

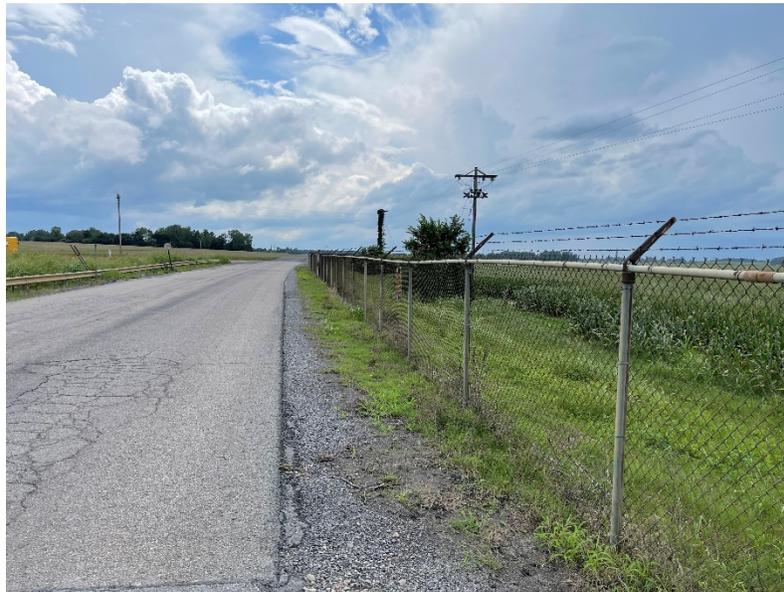
Photograph No. 16
Pond 003
Western embankment (USACE Army Corps of Engineers Levee)
Security fence and downstream slope at right

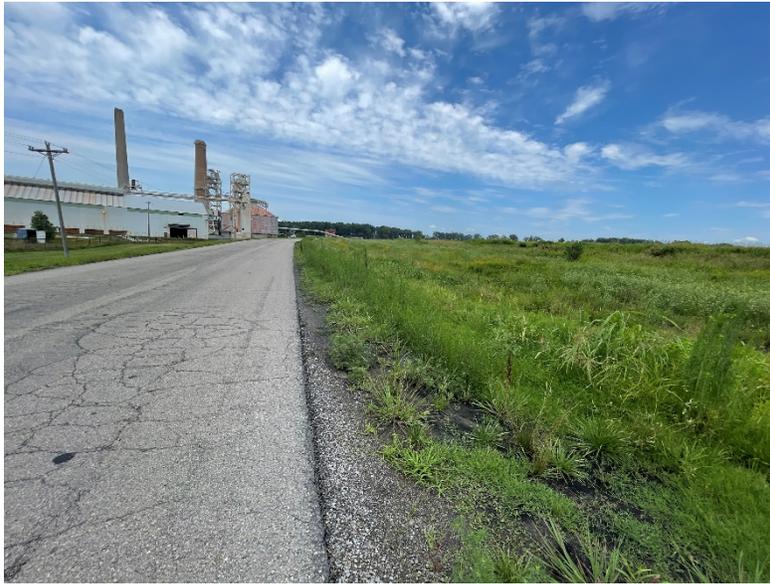
Photograph No. 17
Pond 003
Western embankment crest and upstream slope

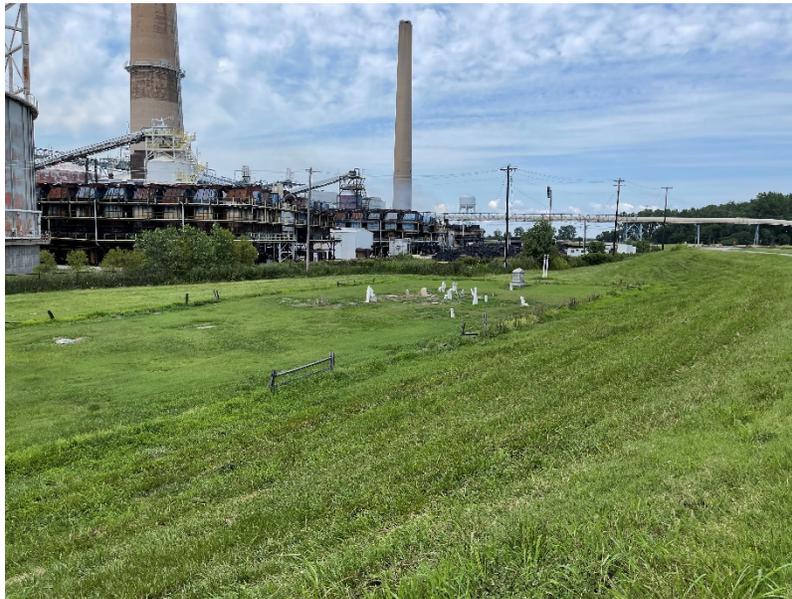
Photograph No. 18
Pond 003
Cemetery near toe of downstream slope of western embankment

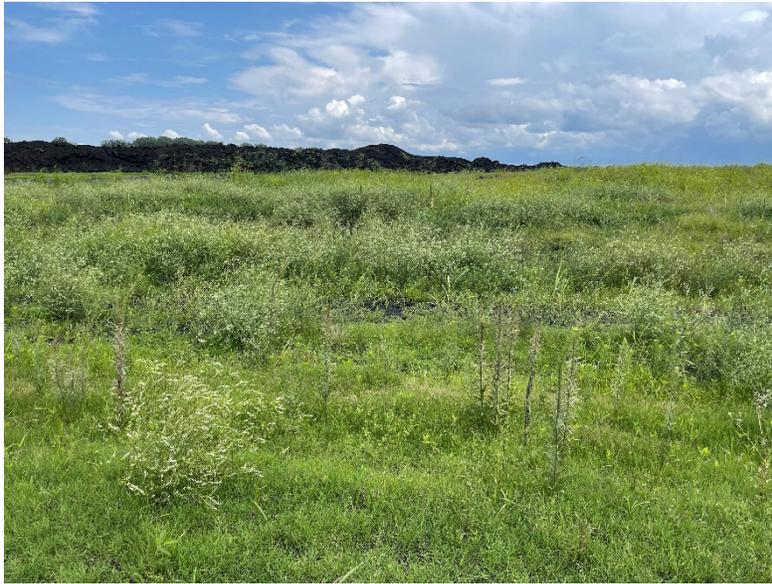
Photograph No. 19
Pond 003
Vegetated stockpiled ash interior to unit

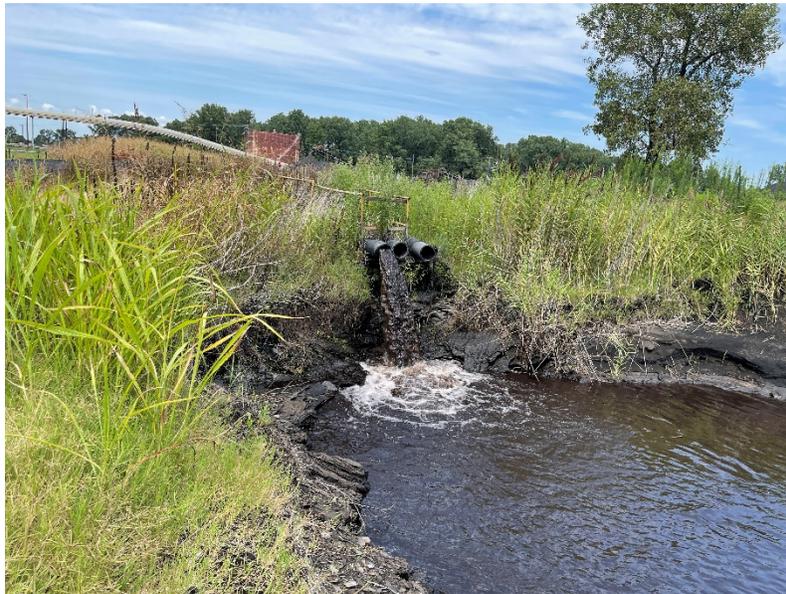
Photograph No. 20
Pond 003
Three inlet pipes interior to unit near northwest corner of unit
One pipe (left) actively sluicing
