**REPORT ON**  
**ANNUAL CCR LANDFILL PE INSPECTION**  
**UTILITY WASTE LANDFILL**  
**NEW MADRID POWER PLANT**  
**NEW MADRID, MISSOURI**

File No. 129342-046  
January 2022

Subject: Annual CCR Landfill PE Inspection  
Utility Waste Landfill  
New Madrid Power Plant  
New Madrid, MO

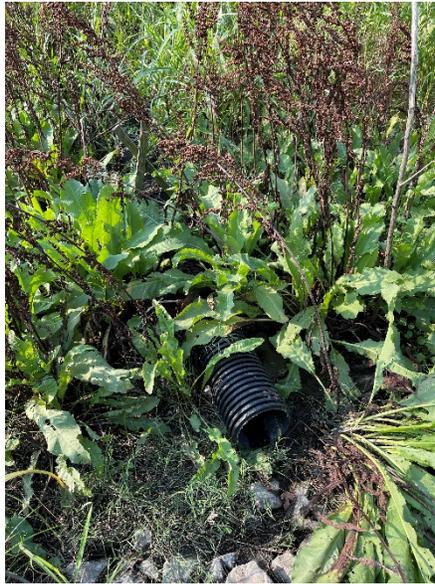
Photograph No. 3

Letdown pipe surrounded by vegetation on Phase I northern face

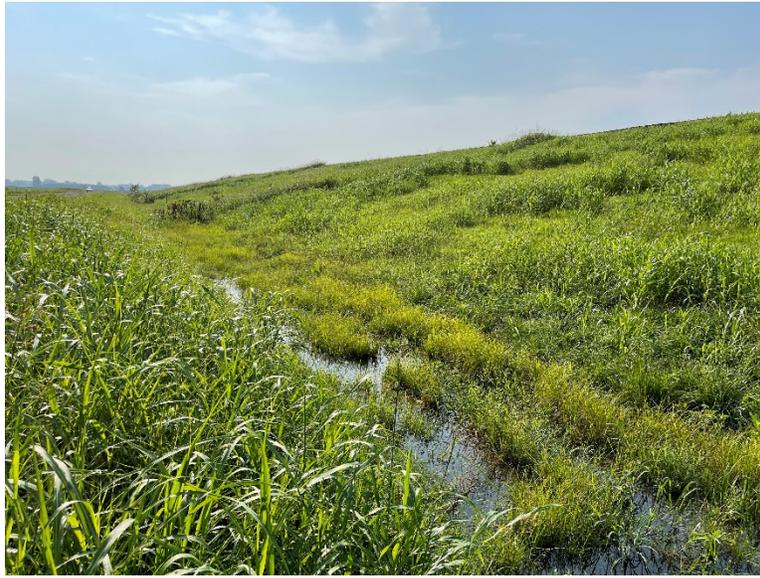
Photograph No. 5  
UWL

The perimeter berms of the landfill were inspected, and no significant erosion, uncontrolled vegetation, or other signs of distress were observed on the inner or outer side slopes. Evidence of irregular slope movement, sloughing, slides, sinkholes, or settlement that would indicate instability in the perimeter berms was not observed during this inspection. In the two days prior to the site inspection, the site received over 3 inches of precipitation. The preceding rainfall events were indicated by the ponded water at the perimeter berms that was observed during the inspection.

Standing water in ditch along upstream slope of Phase I northern perimeter berm

- Pond of water in perimeter berms should be monitored to ensure that swales and associated pipes are operating in accordance with the design.
- Consistent with current AECI maintenance and operation procedures, erosion rills should be monitored along landfill side slopes and maintenance should be conducted to repair areas where erosion rills greater than 12 inches become apparent. We recommend that AECI evaluate causes of erosion (e.g. stormwater flow paths) and determine if measures or re-direction of that flow path are appropriate to limit the erosion development.
- Grassy vegetation on the landfill side slopes should be maintained at a height that facilitates visual inspections. Any and all woody vegetation from the landfill side slopes should be removed.

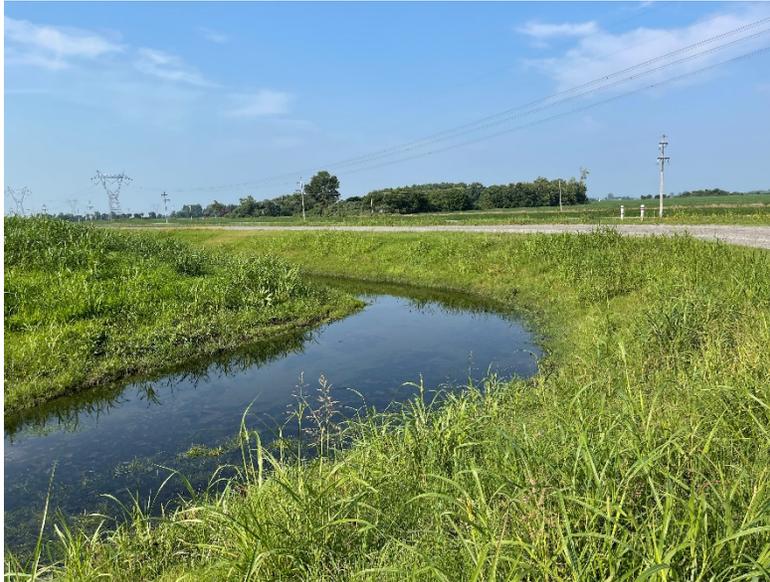
Photograph No. 7  
UWL

Standing water in ditch along upstream slope of Phase I northwestern perimeter berm

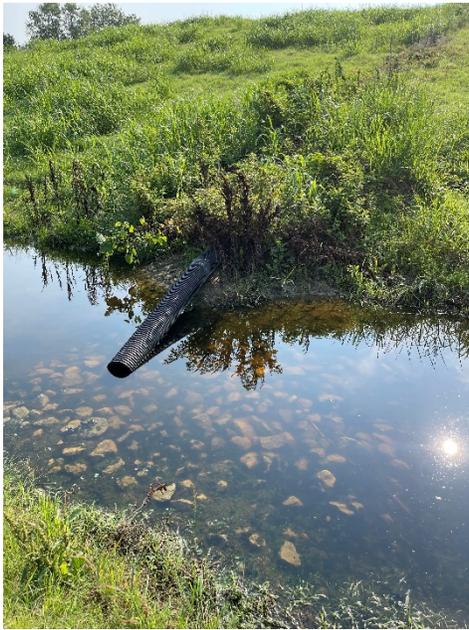
Photograph No. 9  
UWL

Letdown pipe and standing water in ditch at western perimeter of Phase I

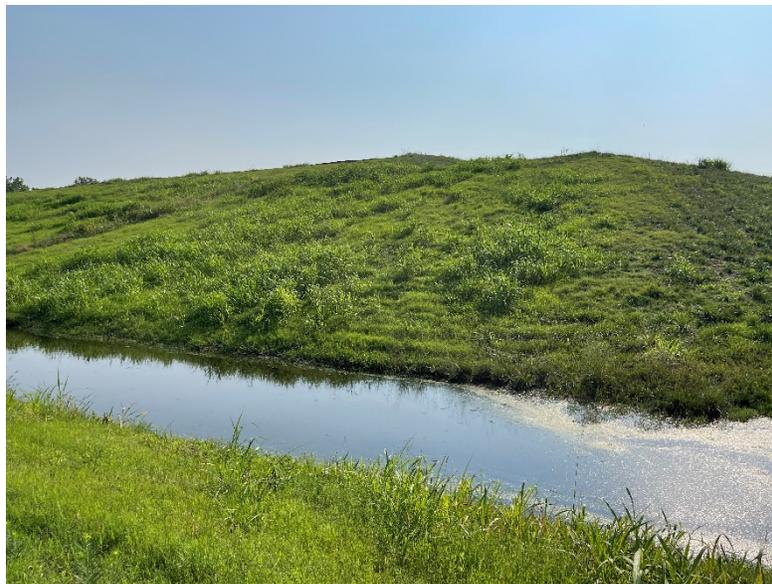
Photograph No. 10  
UWL

Standing water in ditch at southwestern perimeter of Phase I

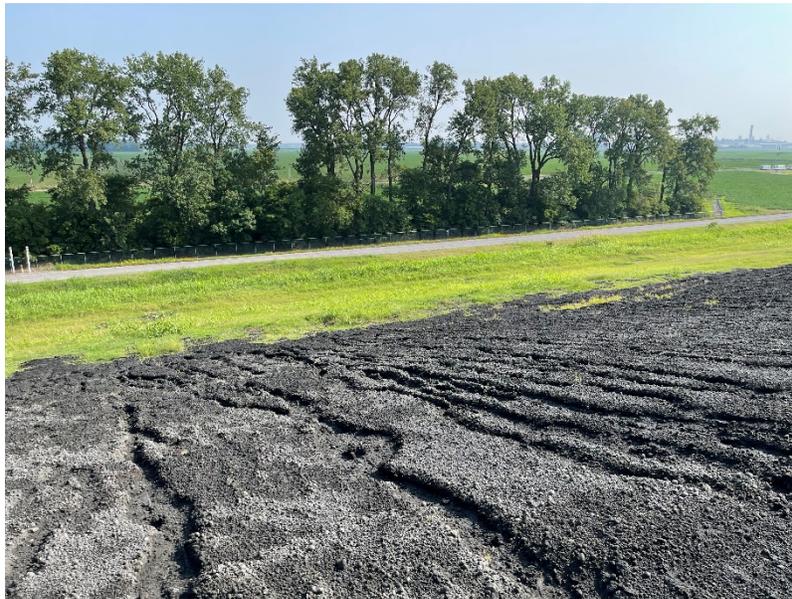
Photograph No. 18  
UWL  
Erosion in exposed CCR on top of northern face of Phase I

Small erosion rills, less than 6-inches deep, and several erosion rills between 6 and 12-inches deep were observed in several locations on the landfill side slopes where intermediate cover had not been placed. No erosion was noted where there was intermediate soil cover, although the thick vegetation made visual inspection difficult. Erosion rills less than 6-inches deep are not an immediate concern but should be monitored regularly by AECI personnel. When erosion rills exceed 12-inches deep, AECI should consider repairing the area and make modifications as needed to prevent future erosion. Based on discussion with plant personnel, the side slopes are maintained and fine graded with a dozer periodically to repair erosion rills. Typical maintenance is conducted on the side slopes once CCR's in the perimeter ditches and along the side slopes are dry enough to perform the grading. At the time of this inspection, intermediate soil cover had been placed to the top of the first bench.

The landfill was visually observed to be stable with no sloughing, slides or evidence of settlement observed. Some minor erosion rills were observed at several locations along the upper side slopes of the landfill (where intermediate cover had not been placed) and these should be monitored in the future and repaired if they continue to erode. Evidence of irregular slope movement, sloughing, slides, sinkholes, or settlement that would indicate instability in the landfill was not observed during this inspection.

See photos/figures in inspection report for further documentation. Continue to monitor smaller erosion rills and consider repair, consistent with current side-slope maintenance operations, if they exceed 12" or more deep. Maintain grassy vegetation and remove any woody vegetation on landfill sideslopes.
