Subject: Annual CCR Surface Impoundment PE Inspection  
Pond 004  
AECI New Madrid Power Plant  
New Madrid, Missouri

**REPORT ON  
INITIAL ANNUAL CCR SURFACE IMPOUNDMENT  
PE INSPECTION  
POND 004  
NEW MADRID POWER PLANT  
NEW MADRID, MISSOURI**

File No. 40616-300  
January 2016

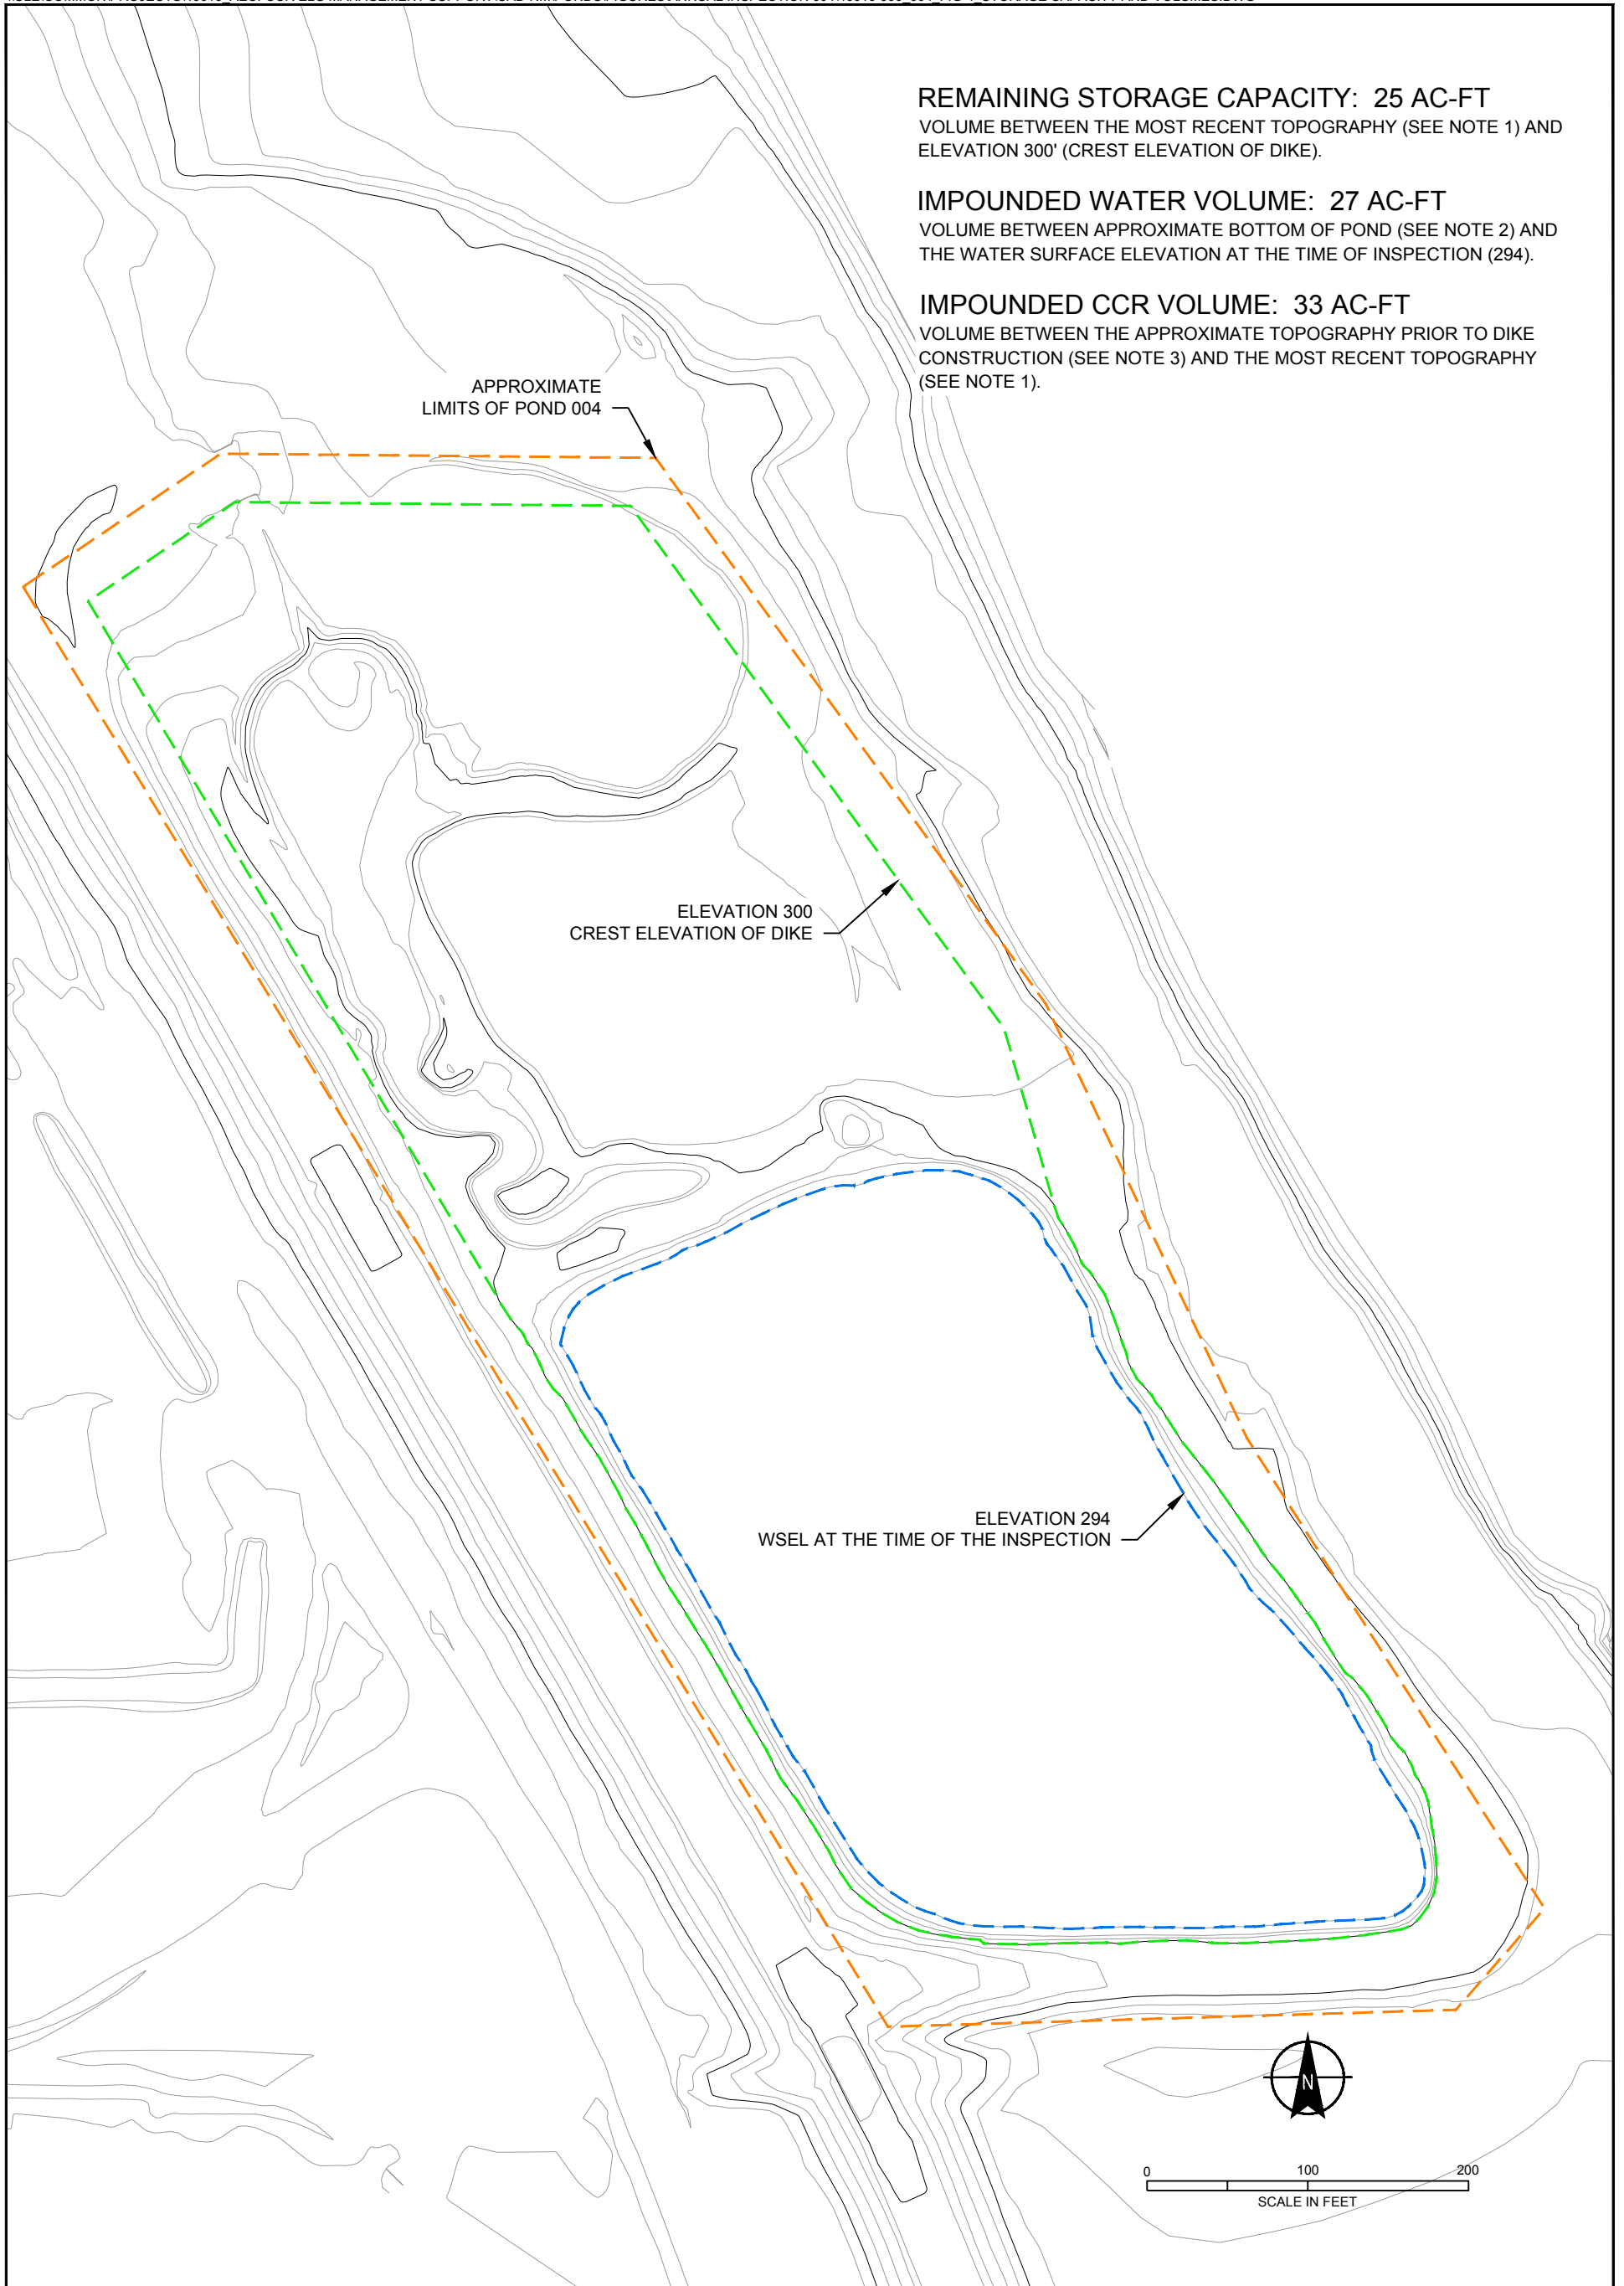
**FIGURE 4**

The remaining storage capacity of the impoundment was approximated to be 25 Acre-ft. As described in Figure 4, the remaining storage capacity was approximated by determining the volume of the impoundment as of the survey conducted 4-8 October 2014 below El. 300 ft., which is the low crest elevation of the dike.

The impounded water volume was approximated to be 27 Acre-ft. As described on Figure 4, the volume of impounded water was approximated by determining the volume of the impoundment as of the survey conducted 4-8 October 2014 below El. 294 ft., the elevation of the pond on the inspection date. Because no bathymetric data was available, the bottom of the pond was approximated to be at El. 286.

The impounded CCR volume was approximated to be 33 Acre-ft. As described on Figure 4, the volume of impounded CCR was approximated by determining the volume between the survey conducted 4-8 October 2014 and the topography provided by USGS 1971, which is the most recent survey prior to impoundment construction.

**REMAINING STORAGE CAPACITY: 25 AC-FT**  
 VOLUME BETWEEN THE MOST RECENT TOPOGRAPHY (SEE NOTE 1) AND ELEVATION 300' (CREST ELEVATION OF DIKE).

**IMPOUNDED WATER VOLUME: 27 AC-FT**  
 VOLUME BETWEEN APPROXIMATE BOTTOM OF POND (SEE NOTE 2) AND THE WATER SURFACE ELEVATION AT THE TIME OF INSPECTION (294).

**IMPOUNDED CCR VOLUME: 33 AC-FT**  
 VOLUME BETWEEN THE APPROXIMATE TOPOGRAPHY PRIOR TO DIKE CONSTRUCTION (SEE NOTE 3) AND THE MOST RECENT TOPOGRAPHY (SEE NOTE 1).

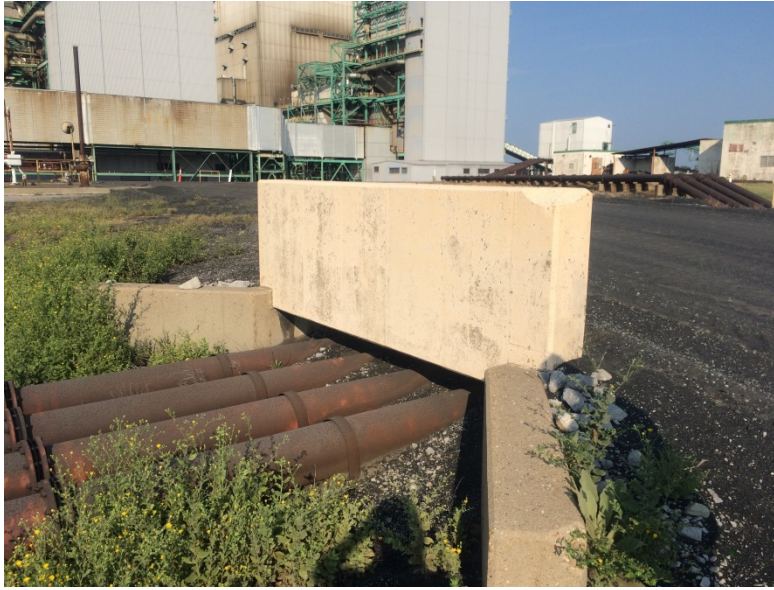
Four (4) 10 in. pipes discharge ash and water into Pond 004. There were no leaks or defects observed in the discharge pipes that required repair.

Photograph No. 1  
Pond 004  
Four inlet pipes with headwall

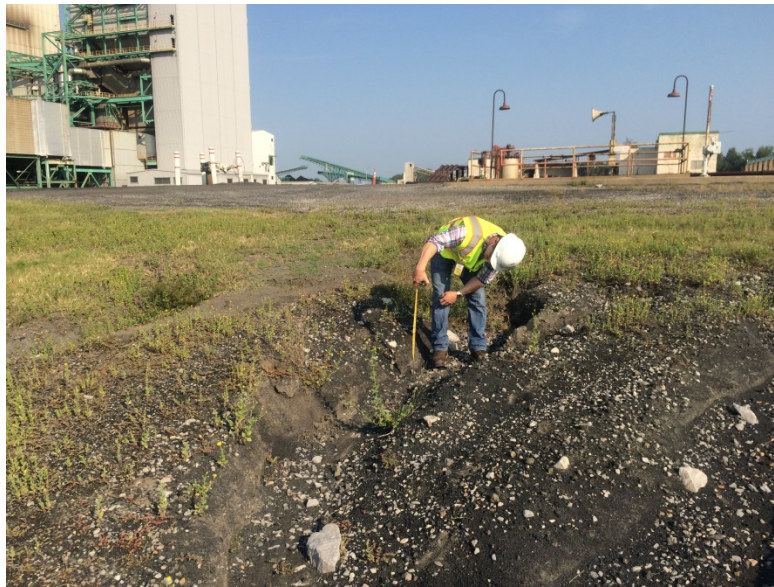
- Minor rutting and erosion in the upstream slope.
- Minor erosion and rutting of the gravel access road on the Northern embankment.
- Sparse vegetation exceeding 6 in. in height and brush on upstream slope within riprap.
- Sparse vegetation exceeding 6 in. height and brush on upstream slope.
- Vegetation exceeding 6 in. in height on the downstream slope.

Photograph No. 2  
Pond 004  
Minor rutting and erosion in upstream slope

- Cut/mow the embankments and routinely mow the embankment slopes (upstream and downstream) and downstream areas to maintain vegetation at a height of 6 in. or less.
- Repair minor ruts and erosion.
- 
- Conduct a video inspection of outlet pipes from the drop inlet structure.

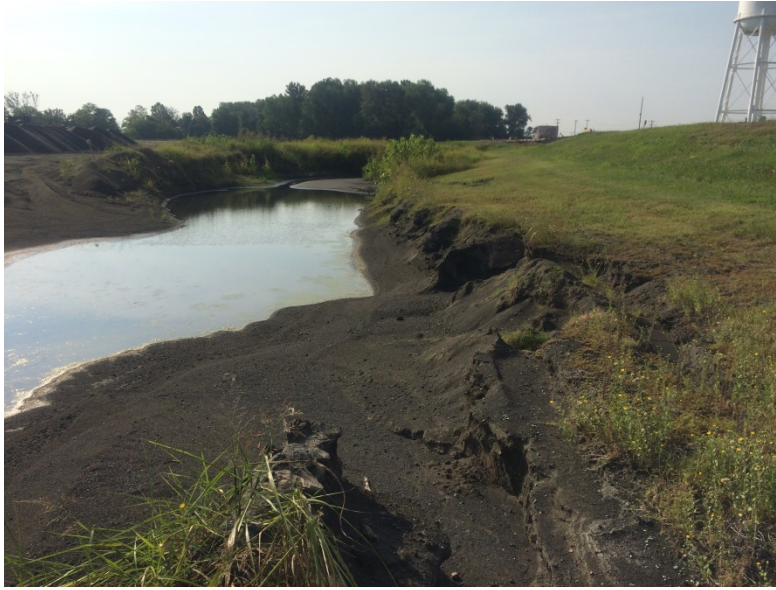
Photograph No. 3  
Pond 004  
Upstream slope of western embankment

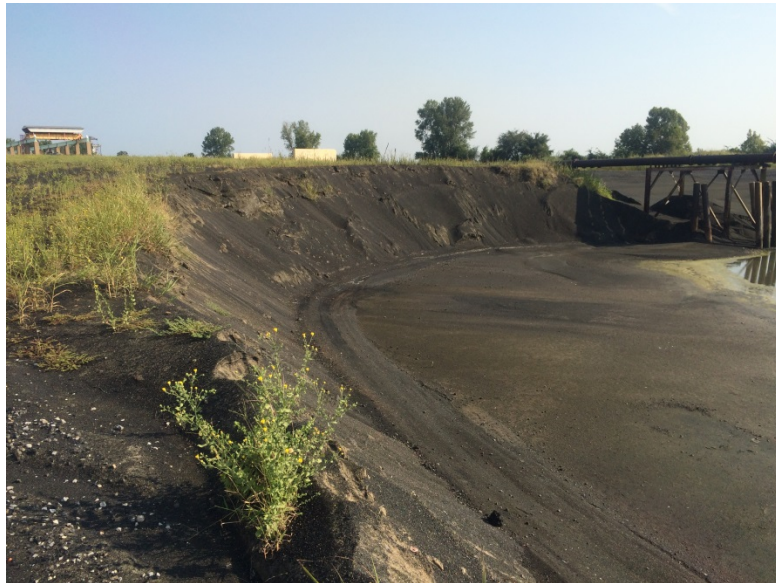
Photograph No. 4  
Pond 004  
Upstream slope of northern embankment

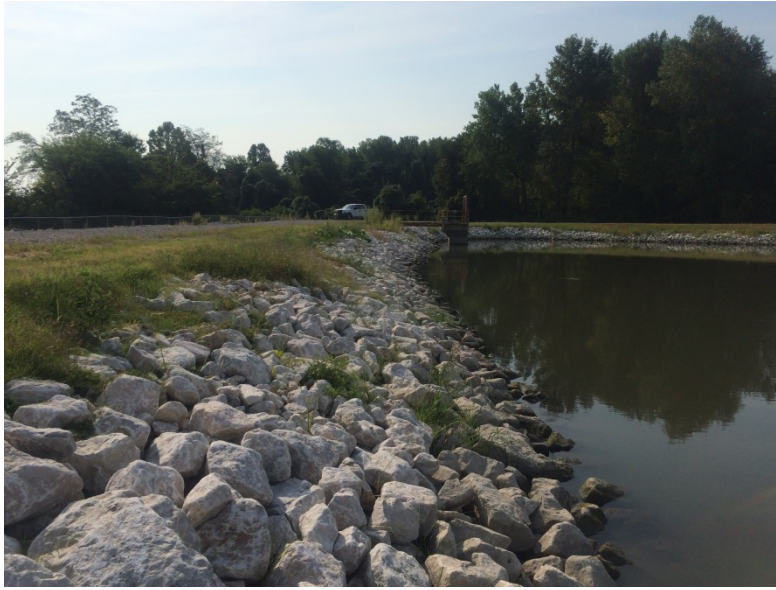
Photograph No. 5  
Pond 004

Upstream slope of eastern embankment with riprap and vegetation

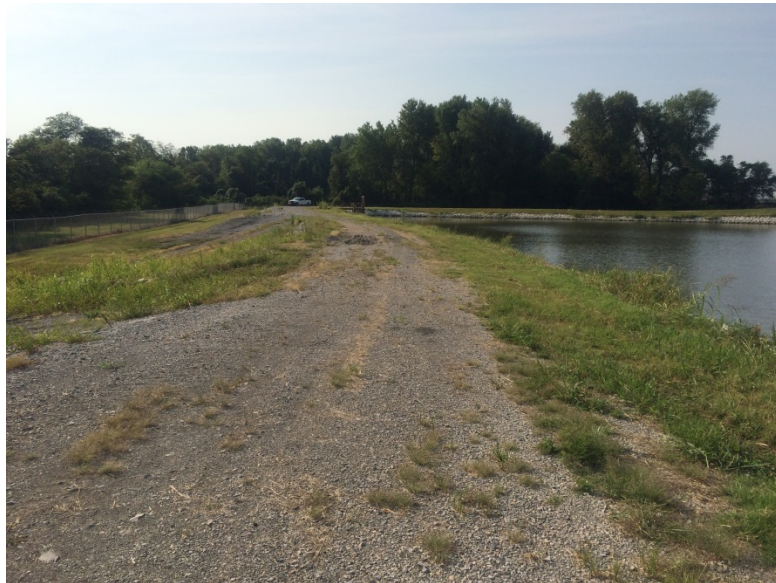
Photograph No. 6  
Pond 004

Crest of eastern embankment

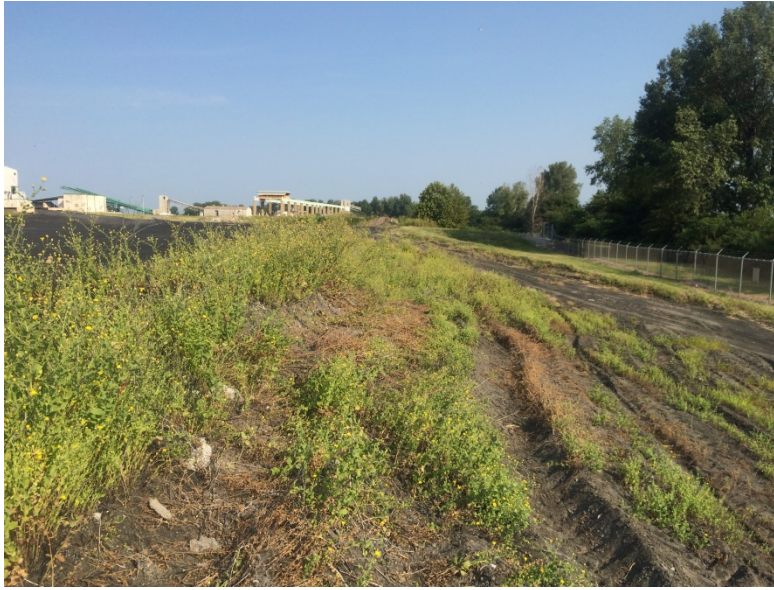
Photograph No. 7  
Pond 004

Downstream slope of eastern embankment with ruts and uneven surface

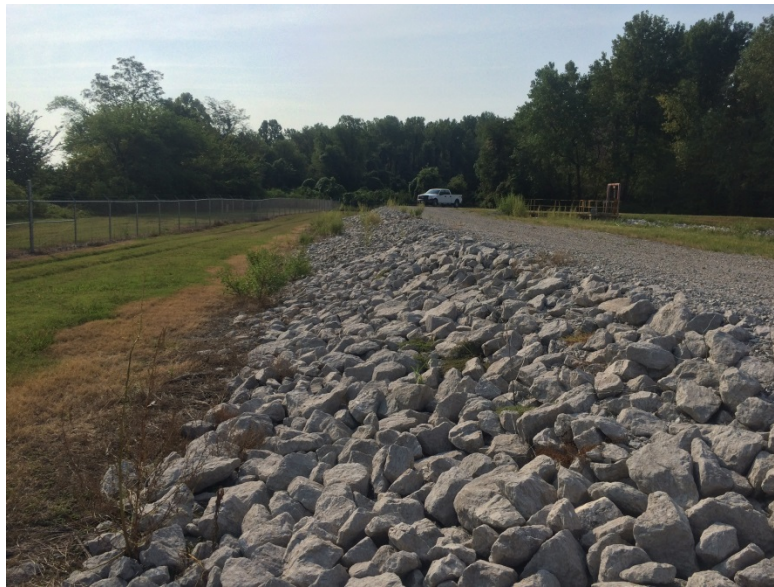
Photograph No. 8  
Pond 004

Downstream slope of eastern embankment with riprap

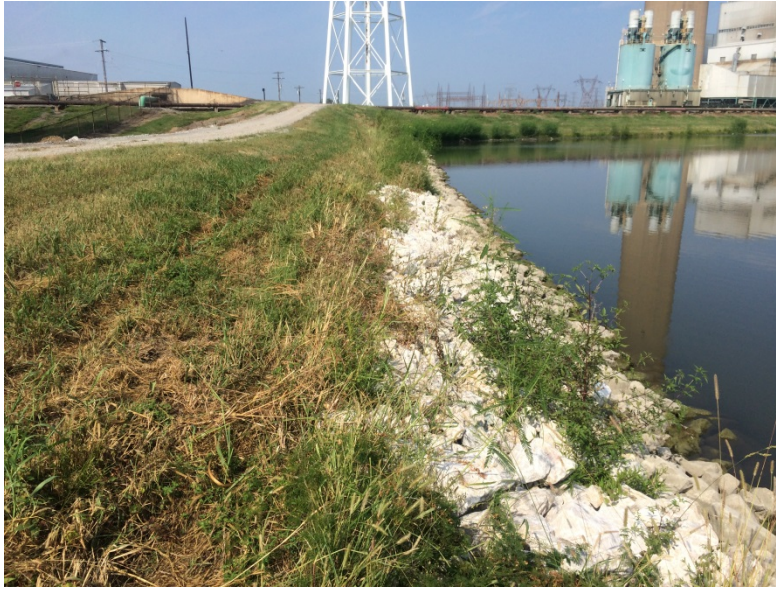
Photograph No. 9  
Pond 004  
Upstream slope with riprap and vegetation

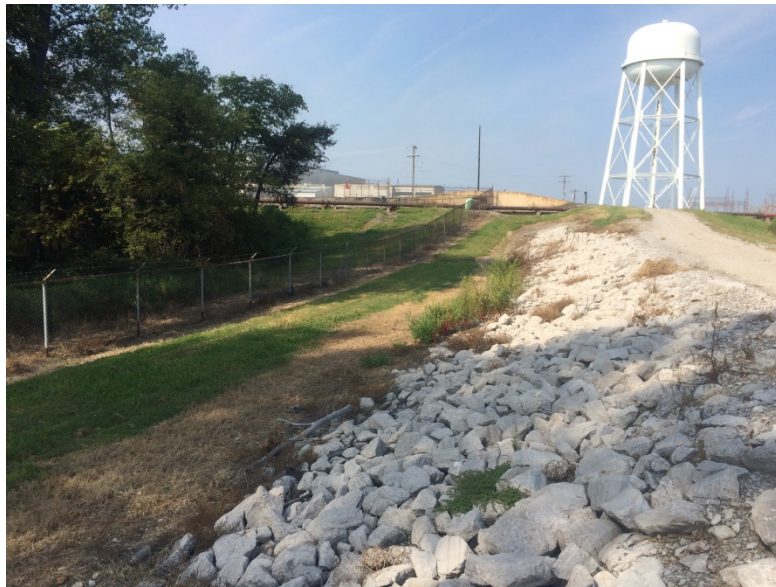
Photograph No. 10  
Pond 004  
Downstream slope with Mississippi River Levee in Background

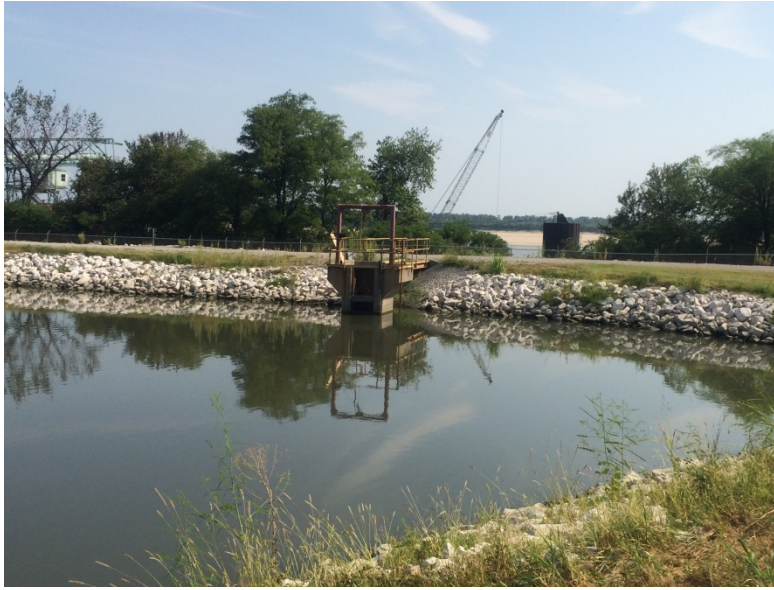
The concrete drop inlet spillway appeared to have minor, isolated, concrete chips and weathering. Minor, surficial rusting was observed on the stoplog removal winch and frame. Deficiencies in the discharge headwall and drainage pipe were not observed.

Photograph No. 11  
Pond 004  
Concrete drop inlet spillway with stoplogs  
Mississippi River in background

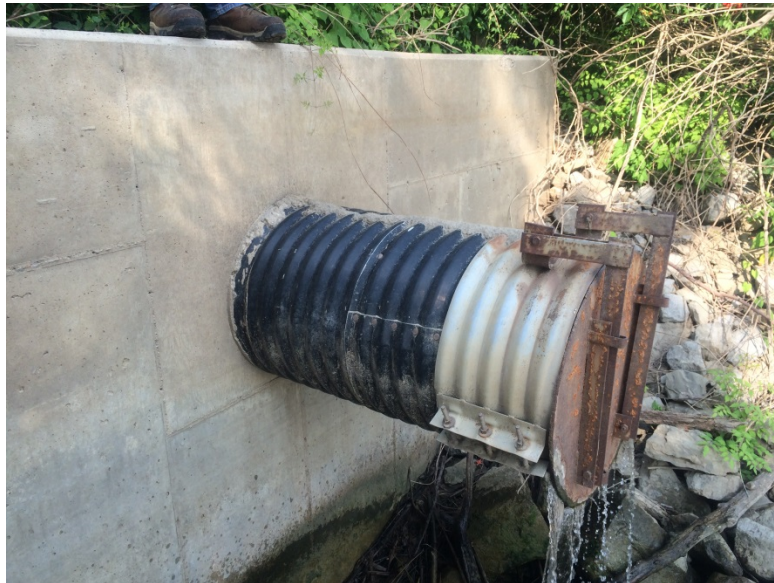
Photograph No. 12  
Pond 004  
Discharge pipe to Mississippi River with backflow preventer
