New Madrid CCR Surface Impoundment

Pond 003

Emergency Action Plan

New Madrid CCR Surface Impoundment Pond 003 Emergency Action Plan

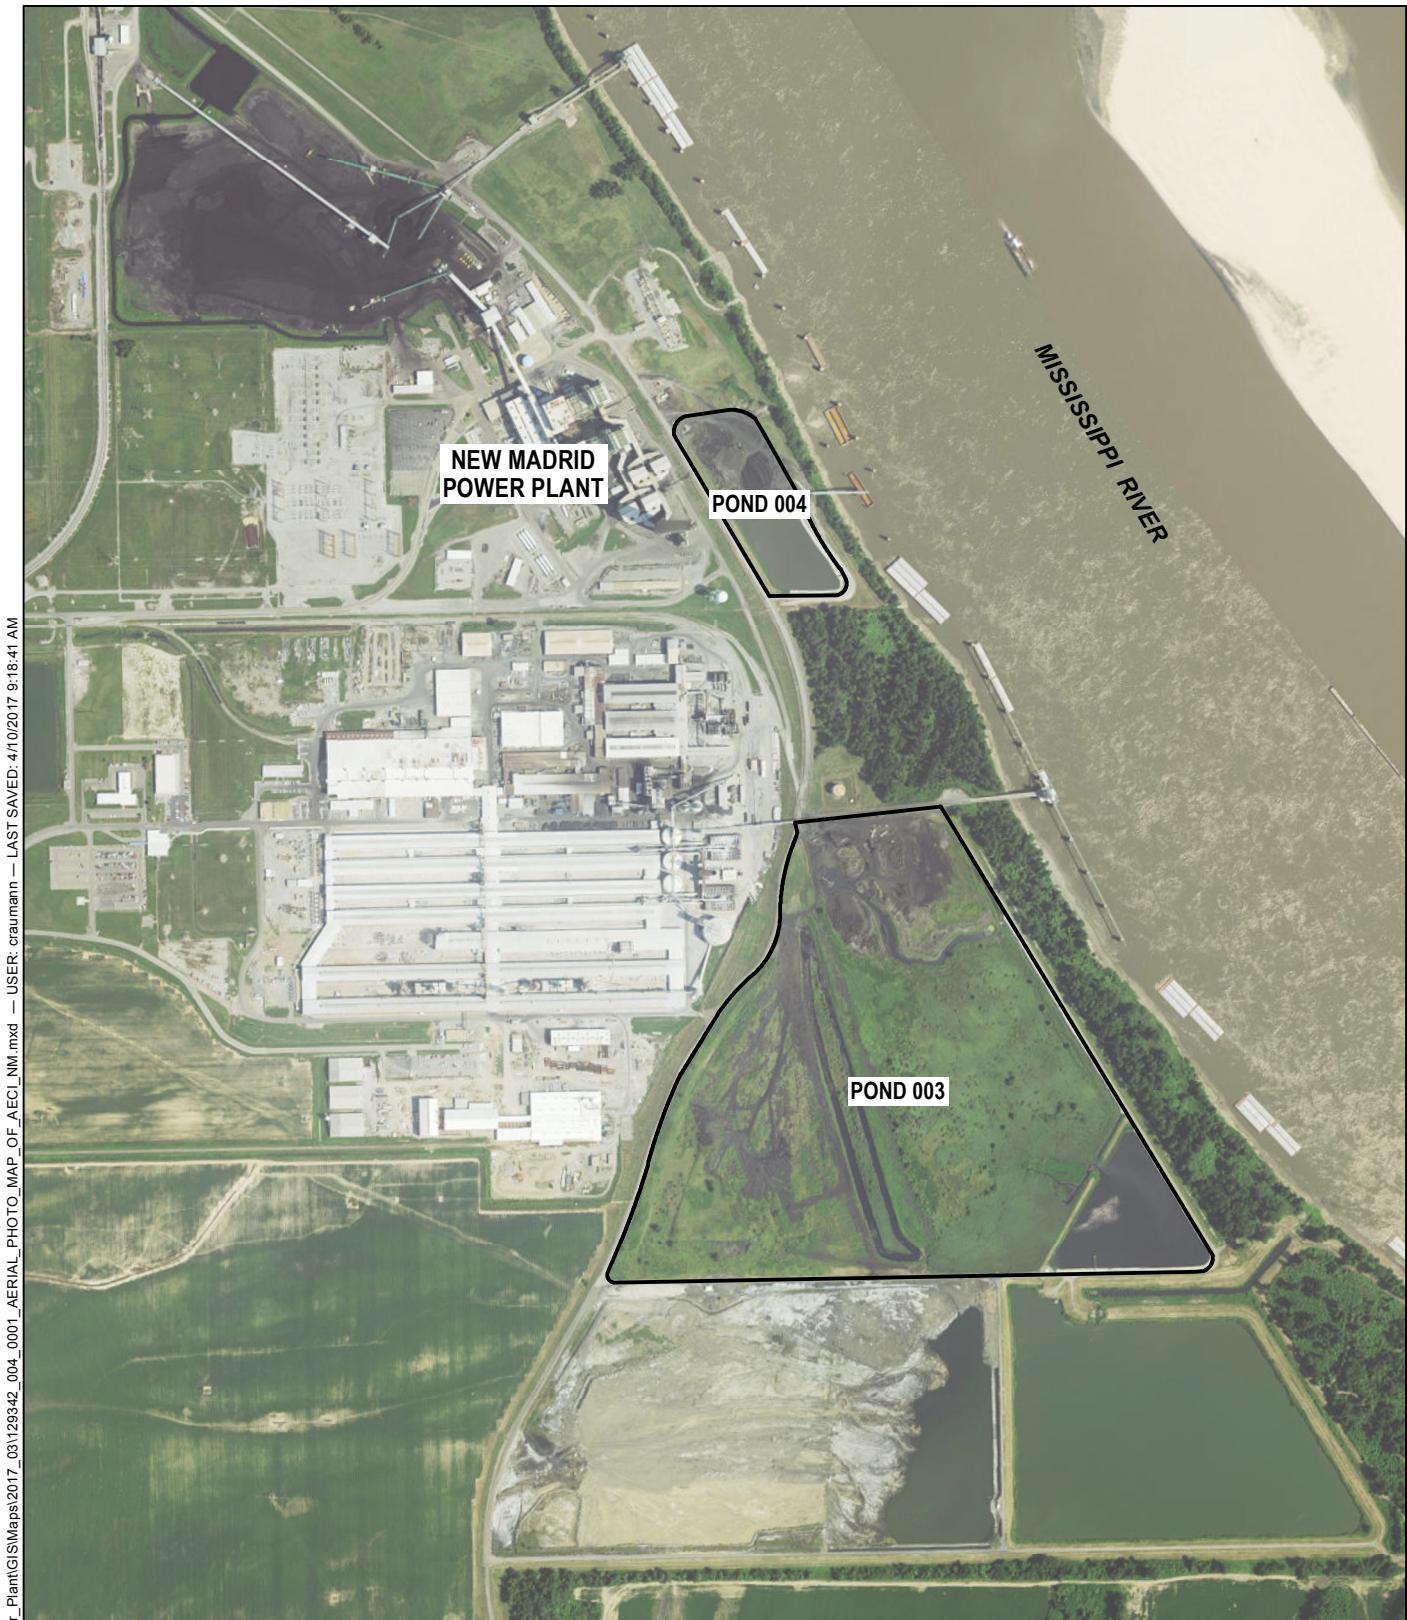
FIGURE 1

AERIAL PHOTO MAP OF THE AECI
NEW MADRID POWER PLANT AND
CCR SURFACE IMPOUNDMENTS

Associated Electric Cooperative Inc. (AEKI) has developed and will implement this EAP in the event an impoundment failure occurs at their New Madrid Power Plant CCR Surface Impoundment – Pond 003 (Pond 003) (see Figures 1 and 2). In addition, this plan is written in accordance, and to comply, with 40 CFR Part 257.73(a)(3)(i). This EAP provides step-by-step instructions to those individuals at the plant level on how to respond to an emergency situation. The plan includes notification lists, maps of the CCR surface impoundment, and emergency response procedures. The main goal of this EAP is to offer a quick and effective reference for personnel at the facility in case such an emergency should occur.

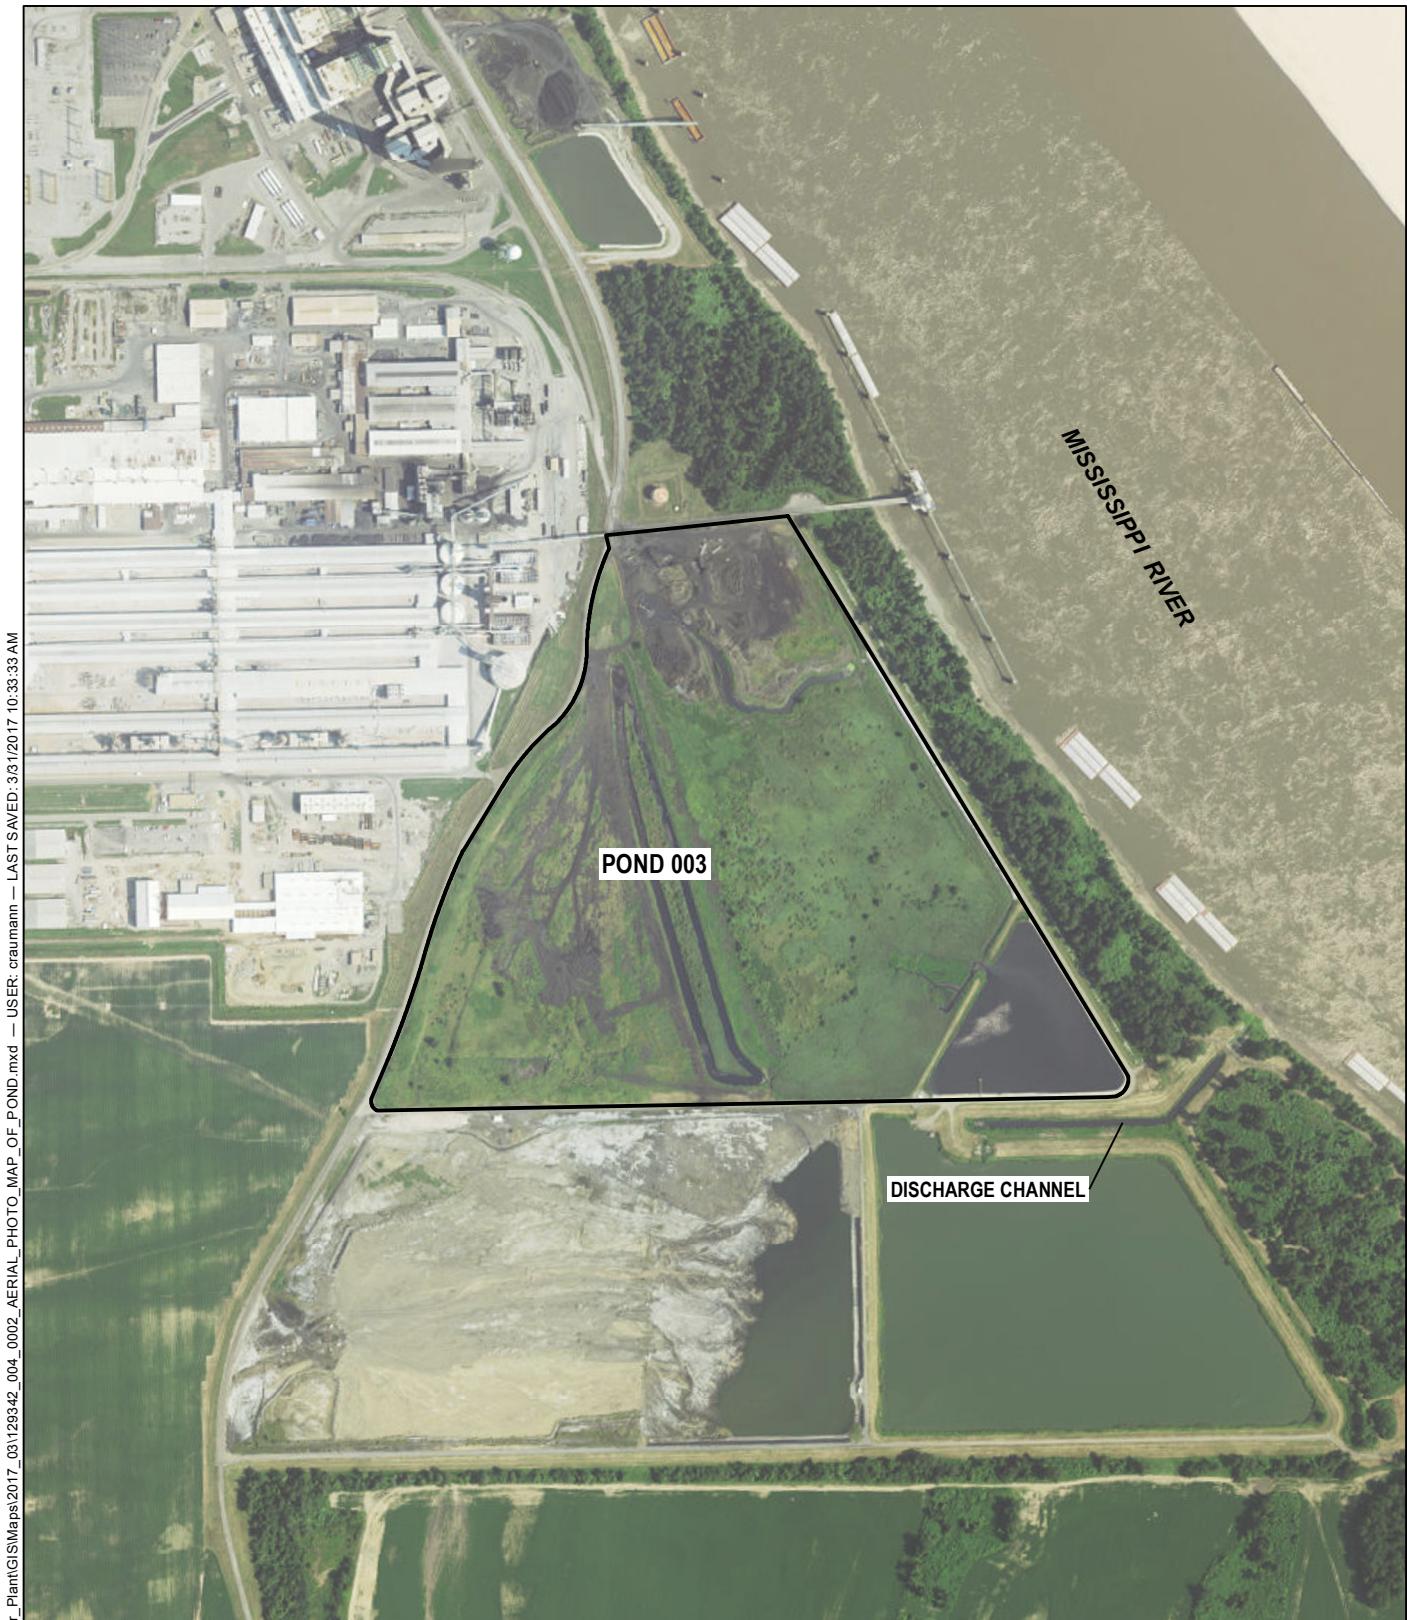
FIGURE 2

AERIAL PHOTO MAP OF POND 003

The watershed in which Pond 003 is located is the Little River Ditches Watershed (USGS No. 08020204) that is approximately 2,608 square miles in size. Pond 003 is an above-grade ring dike and does not receive any overland flow from the surrounding areas. Discharges from the impoundment flow to a concrete drip inlet structure with concrete stoplogs located in the southeast corner of Pond 003. A discharge pipe directs water through the dike and into a discharge channel that flows to the Mississippi River as shown on Figure 2.

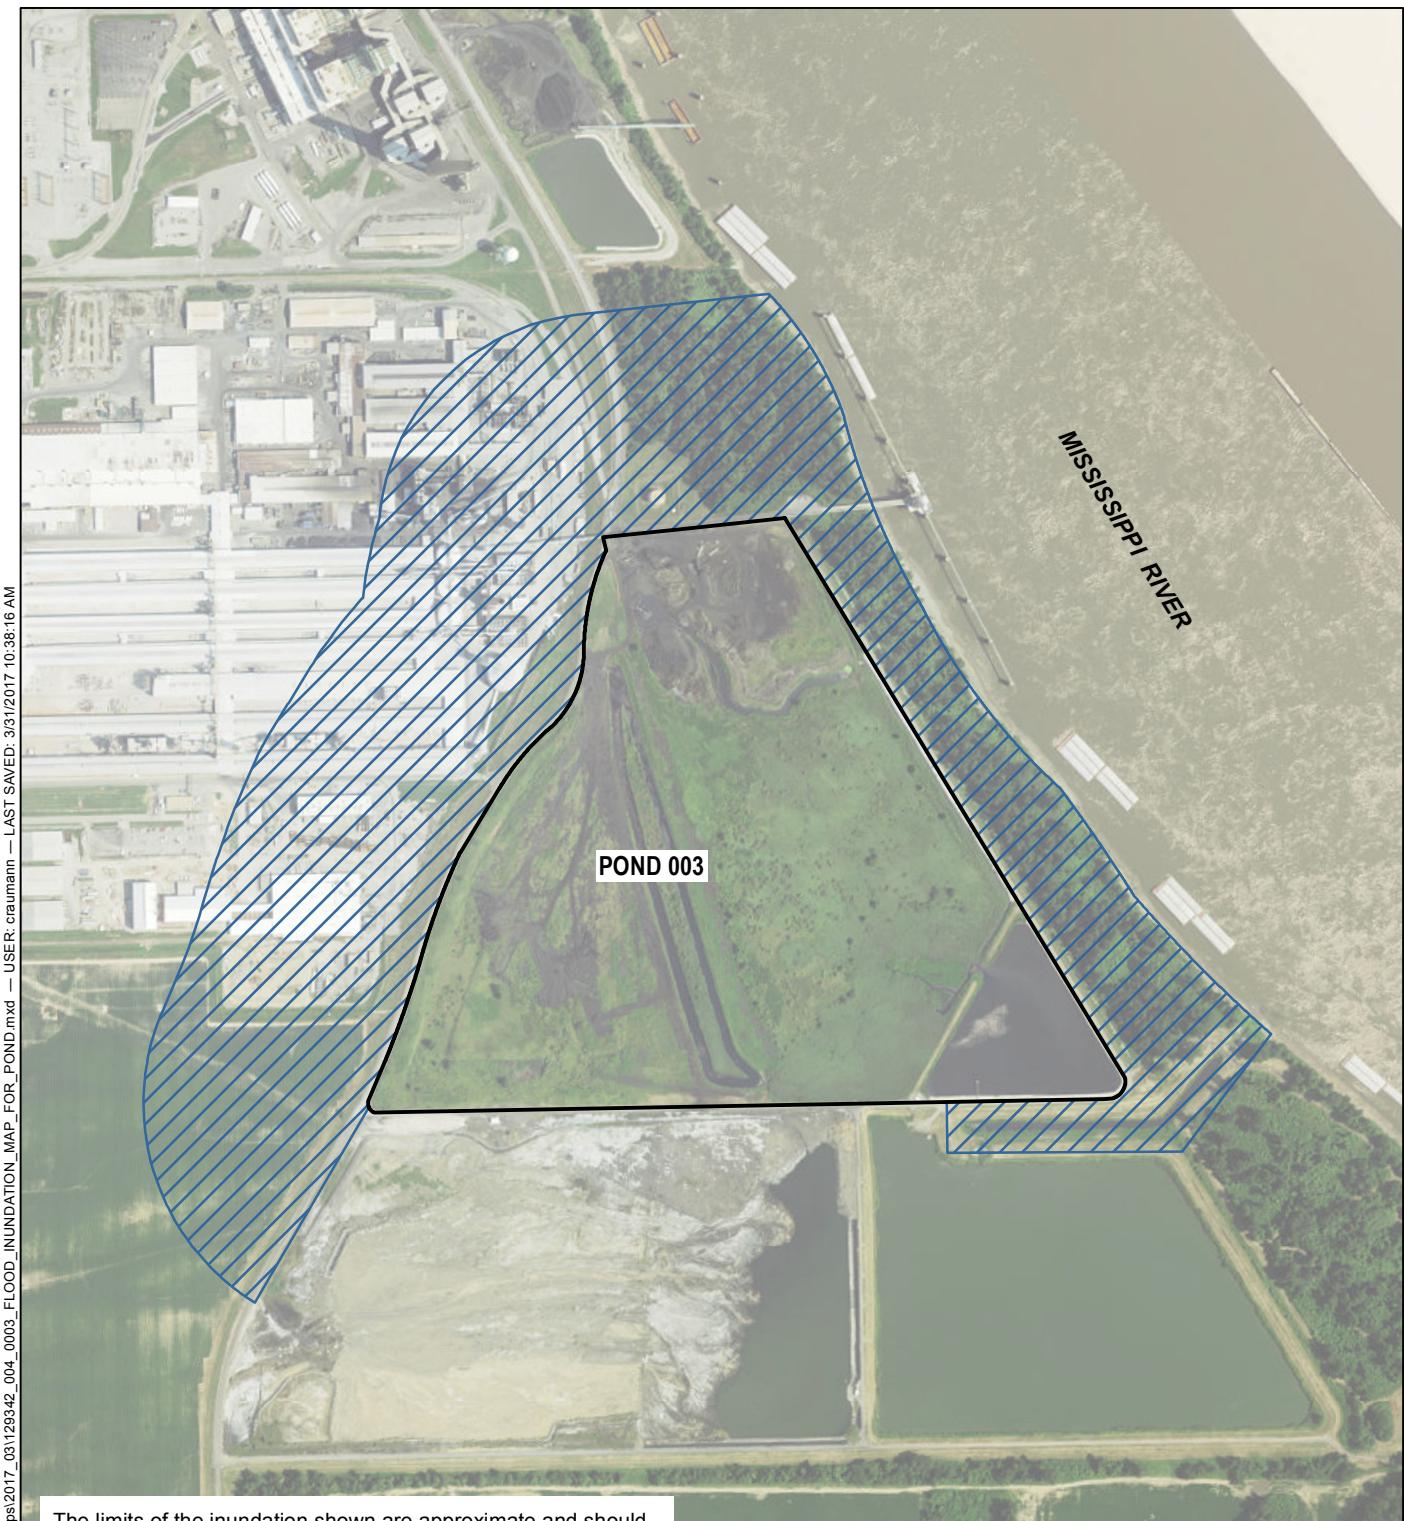
FIGURE 3

The limits of the inundation shown are approximate and should be used only as a guideline for establishing evacuation zones. Areas inundated will depend on actual failure conditions and may differ from the areas shown on this map.

POND 003 FLOOD INUNDATION MAP

The Flood Inundation Map for Pond 003 (Figure 3) indicates the potential areas that may be affected if the impoundment should fail. Based on the flood inundation mapping, the potentially affected areas include uninhabited farm land to the south and southwest, the AEKI power plant property to the northwest, and other industrial facilities to the west. No other structures or buildings have been identified in this inundation area.
